# Manhole Inspection Summary

Manhole # S13GG1026MH

Insp Date: **6/12/07 2:39 PM**

**Location** Address: **4259 PARK HEIGHTS**

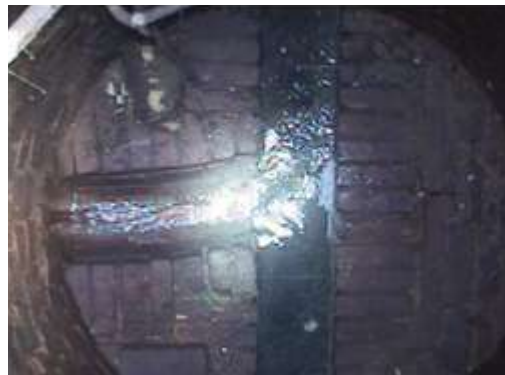
Top View

DEBRIS ON BENCH

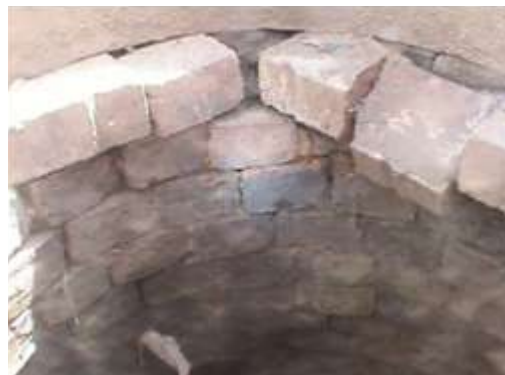
Defect 2

Condition: ☐ Sound ☐ Cracked ☐ Root Intrusion ☒ **Loose Brick** ☒ **Deteriorated**

LOOSE BRICKS AND  
DETERIORATING FRAME  
ADJUSTMENT

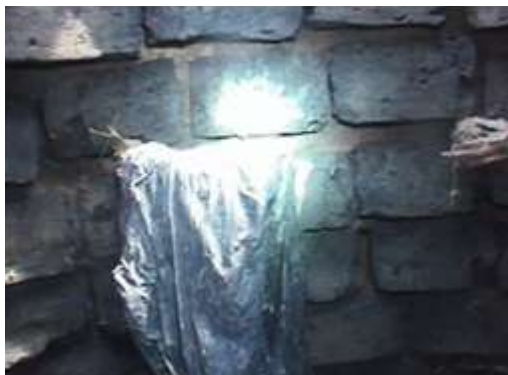
Defect 1

Count: **3** Missing: **1** ☒ **Corroded**

☒ **Evidence Of Surcharge** Depth: **2** (ft.) ☐ Active Surcharge Present

MISSING/CORRODED RUNG AND  
EVIDENCE OF SURCHARGE

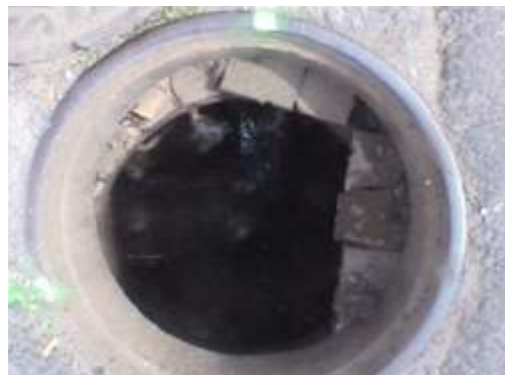
Defect 3

Offset: **3** (in.)

OFFSET FRAME

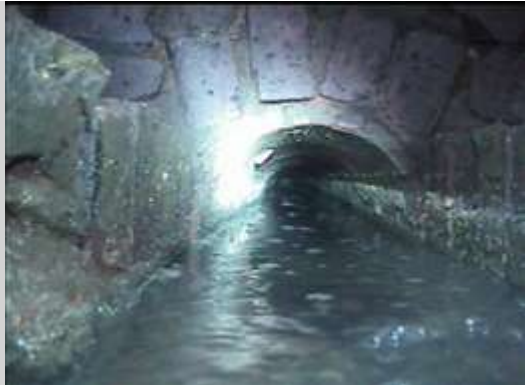
12 O'Clock Outflow

Infiltration: **None** Pipe Seal Cond: **Cracked**

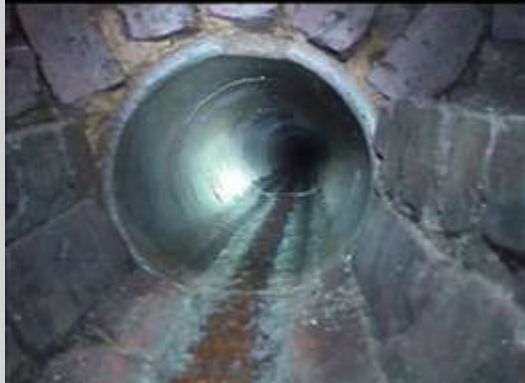
9 O'Clock Inflow

Infiltration: **None** Pipe Seal Cond: **Broken**
